LOCAL CONCEPT DEVELOPMENT STUDY FOR CAPE MAY COUNTY ROUTE 619
(OCEAN DRIVE) BRIDGE (STRUCTURE No. 3100-002)
LOCATED OVER CORSONS INLET
UPPER TOWNSHIP

NAVIGATION IMPACT REPORT

MARCH 2026

MICHAEL BAKER INTERNATIONAL, INC.

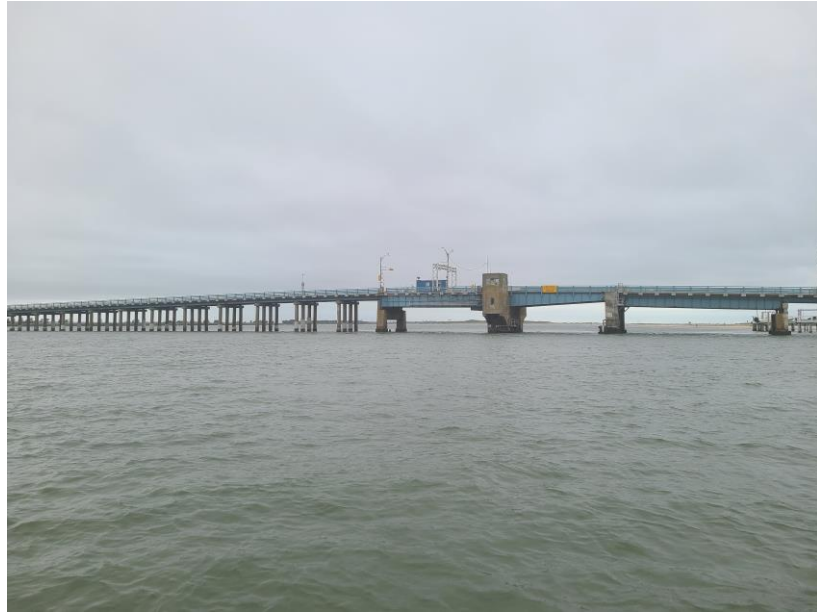
Figure 2. Corsons Inlet Bridge with closed bascule (8/20/2025)

It has two 12' wide lanes with no shoulders and 1'-6" safety walks on both sides. The approach span superstructure is composed of three steel stinger with reinforced concrete deck, the remaining spans are girder, floor beam and stringer system. The substructure consists of reinforced concrete pile bents for all approach spans and stub abutments on timber piles. The vertical under clearance at the bascule span is approximately 15' to the mean high-water (MHW) line with a 50' horizontal clearance for navigational purposes.

The Corsons Inlet bridge carries the CR 619 Ocean Drive over the Corsons Inlet. It is a 1,485' long bridge consisting of Thirty Nine (39) spans of which Thirty Six (36) are 35' approach spans, two are 79' spans, one on each side of the 65' bascule span. The bascule span is exhibiting severe corrosion to the trunnion columns and the bascule span has not been operational since 2013 due to electrical, mechanical and structural issues associated with bascule as well as deficiencies with the supporting superstructure below.
